## FINAL REPORT

### CABOT OIL & GAS CORPORATION HEITSMAN #2V/#4H WELLSITE DIMOCK TOWNSHIP, PENNSYLVANIA

MAY 2010

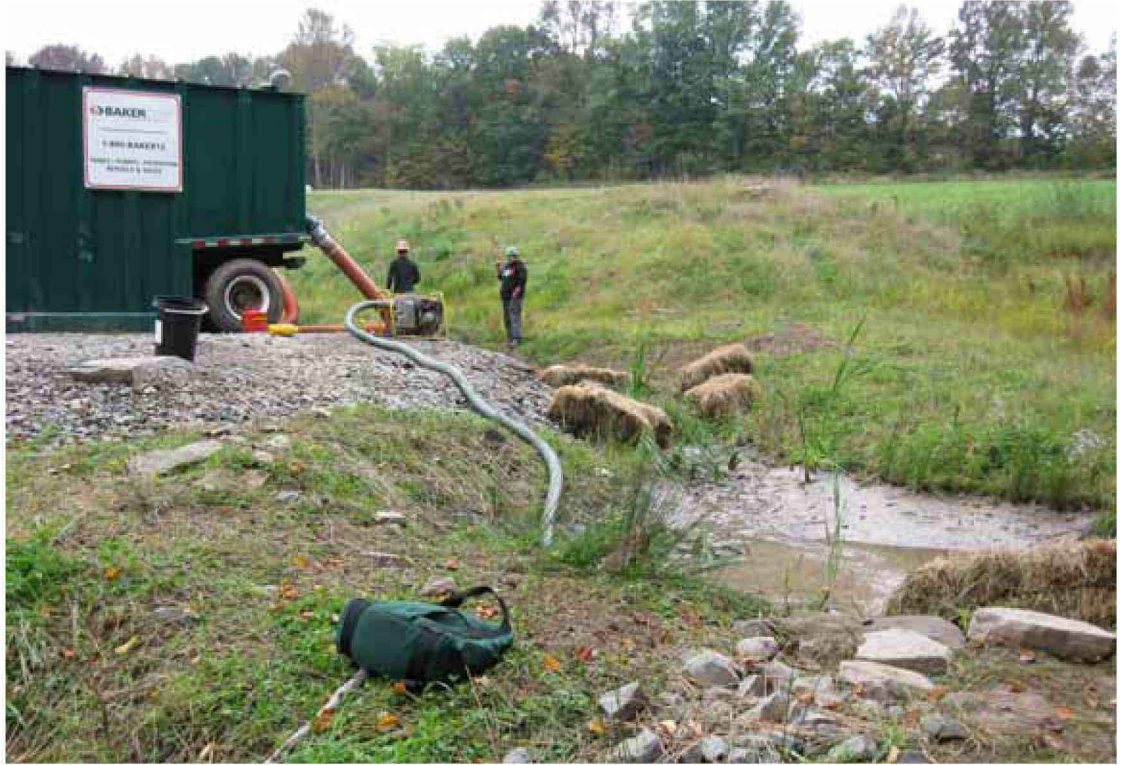
**Photo No.**  
**30**

Catchment basin at the southwest corner of the well pad. Note that fresh water from the basin is being pumped from the basin after being flushed from the drainage swale back up to the well pad for storage and disposal.

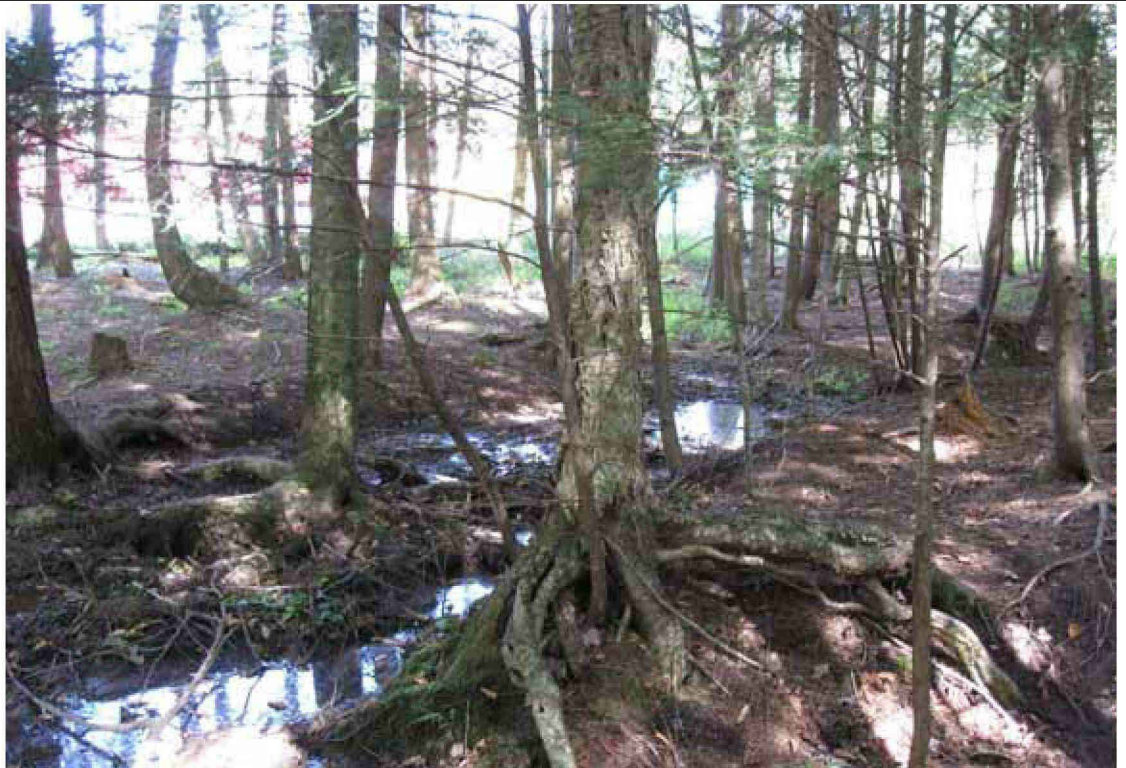
Remediated pathway of migration of frac fluid in the wooded wetland. Note residual pool of fresh water present after fresh water flushing used to remediate the affected area.

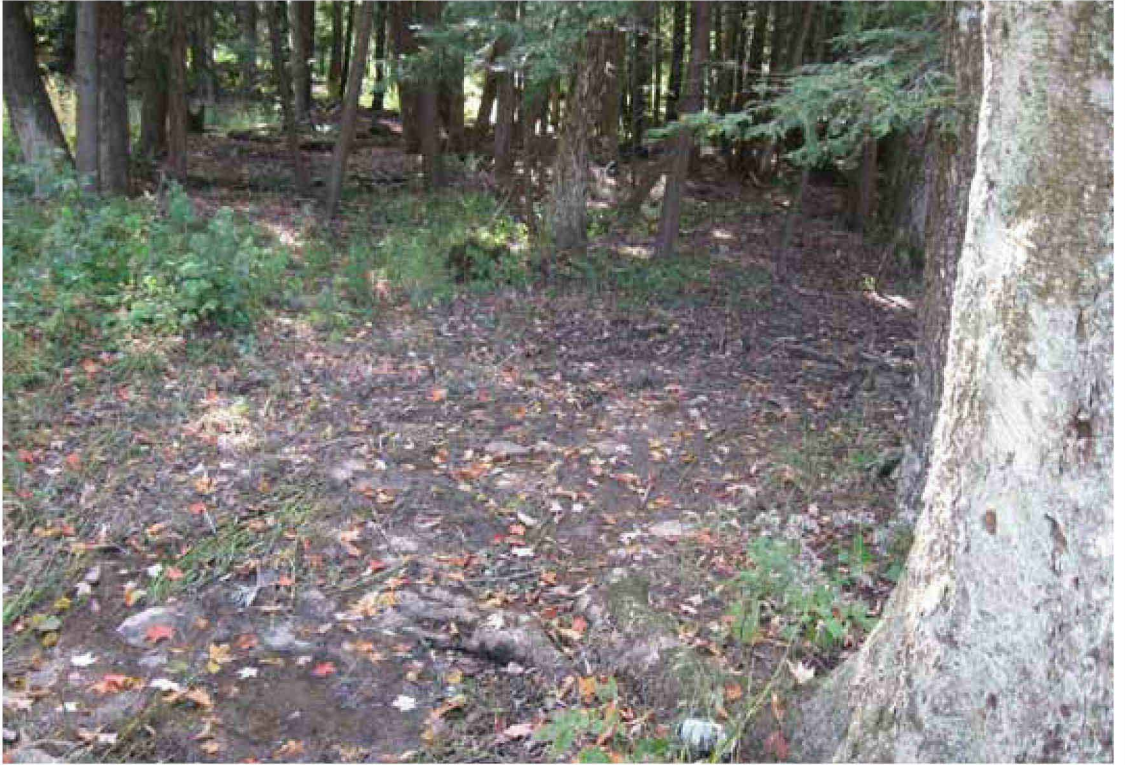
<b>Site Location:</b> Susquehanna County, Pennsylvania	<b>Project No.</b> 39938634.00008
<b>Photo No.</b> <b>31</b>	<b>Date:</b> 9/22-23/09

<b>Direction Photo Taken:</b> West			
<b>Description:</b> Remediated pathway of migration of frac fluid in the wooded wetland.

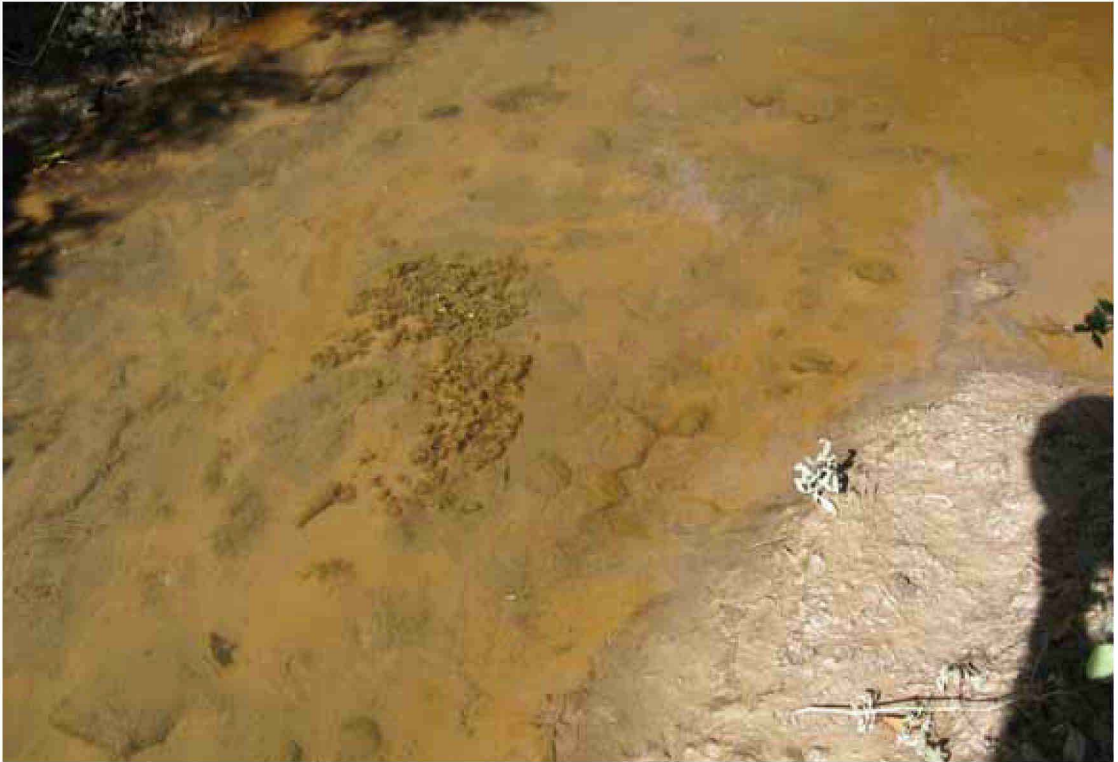
<b>Site Location:</b> Susquehanna County, Pennsylvania	<b>Project No.</b> 39938634.00008
<b>Photo No.</b> <b>33</b>	<b>Date:</b> 9/22-23/09

<b>Direction Photo Taken:</b> Northwest			
<b>Description:</b> Remediated portion of Stevens Creek. Note unaffected brown sediment containing naturally occurring, occasional iron staining on sediments and clear appearance of water.
